Thule Air Base Airfield White Painting and Permafrost Investigation

Phases I–IV

June 2013

Final report

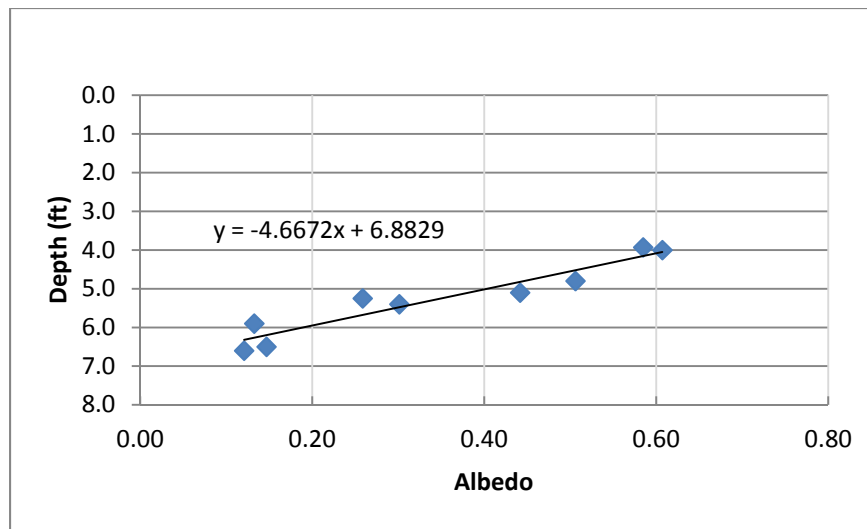
GPR was used to measure the thaw depth for the various albedos. As noted previously, GPR works very well for dielectrically contrasting horizontal reflectors. During summer measurements, thawed, wet material of the active layer overlies the frozen permafrost soils. It is possible to obtain relatively accurate measurements of depth by surveying with GPR a known object in the subsurface at a known depth and then calibrating the GPR parameters to this known object. This was done on Taxiway Bravo, where the culvert draining Lake Eddy crosses the taxiway. The culvert depth was measurable from the side of the taxiway embankment. The GPR measuring of active layer depth was confirmed during test pit excavation and borehole drilling and is good to ± 0.25 ft. The albedo values are shown in Table 3 and are plotted in Figure 19. This relationship is linear and, for the brightest of paint, the albedo approaches to 0.60 with the thaw depth being near 4 ft, while the natural black surfaces approach 0.12 with thaw depth of 6.5 ft. This white vs. black difference in thaw depth coincides with the ACFEL study of 1953, where over 2 ft of thaw reduction was measured. Photos of the various stages of paint measured for albedo are shown in Figures 20 to 23.

Figure 19. Albedo vs. thaw depth.

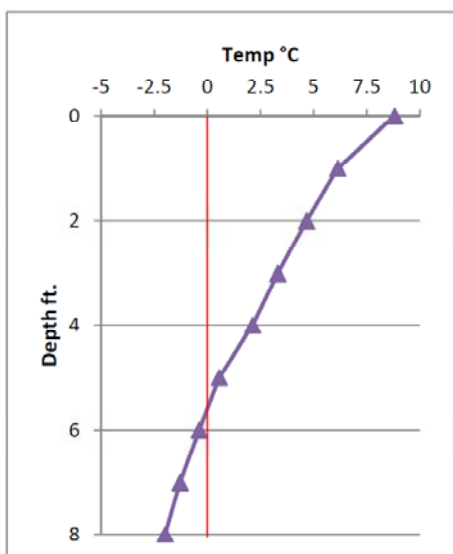
Figure 29. Subsurface temperatures measured at the “White Pavement” site. Measurement taken 11 August 2011 is the deepest thaw obtained for that summer. The albedo was 0.32 and the depth is almost 5.5 ft. This is consistent with the albedo vs. thaw depth presented in this report.

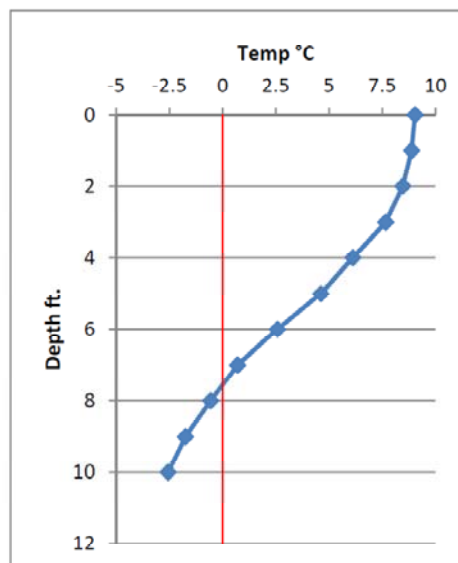
Figure 30. Subsurface temperatures measured at “Black Pavement” site. Measurement taken 11 August 2011 and is deepest thaw obtained for that summer, almost 7.5 ft, which is approximately 1 ft deeper than other measurements in natural colored pavement.

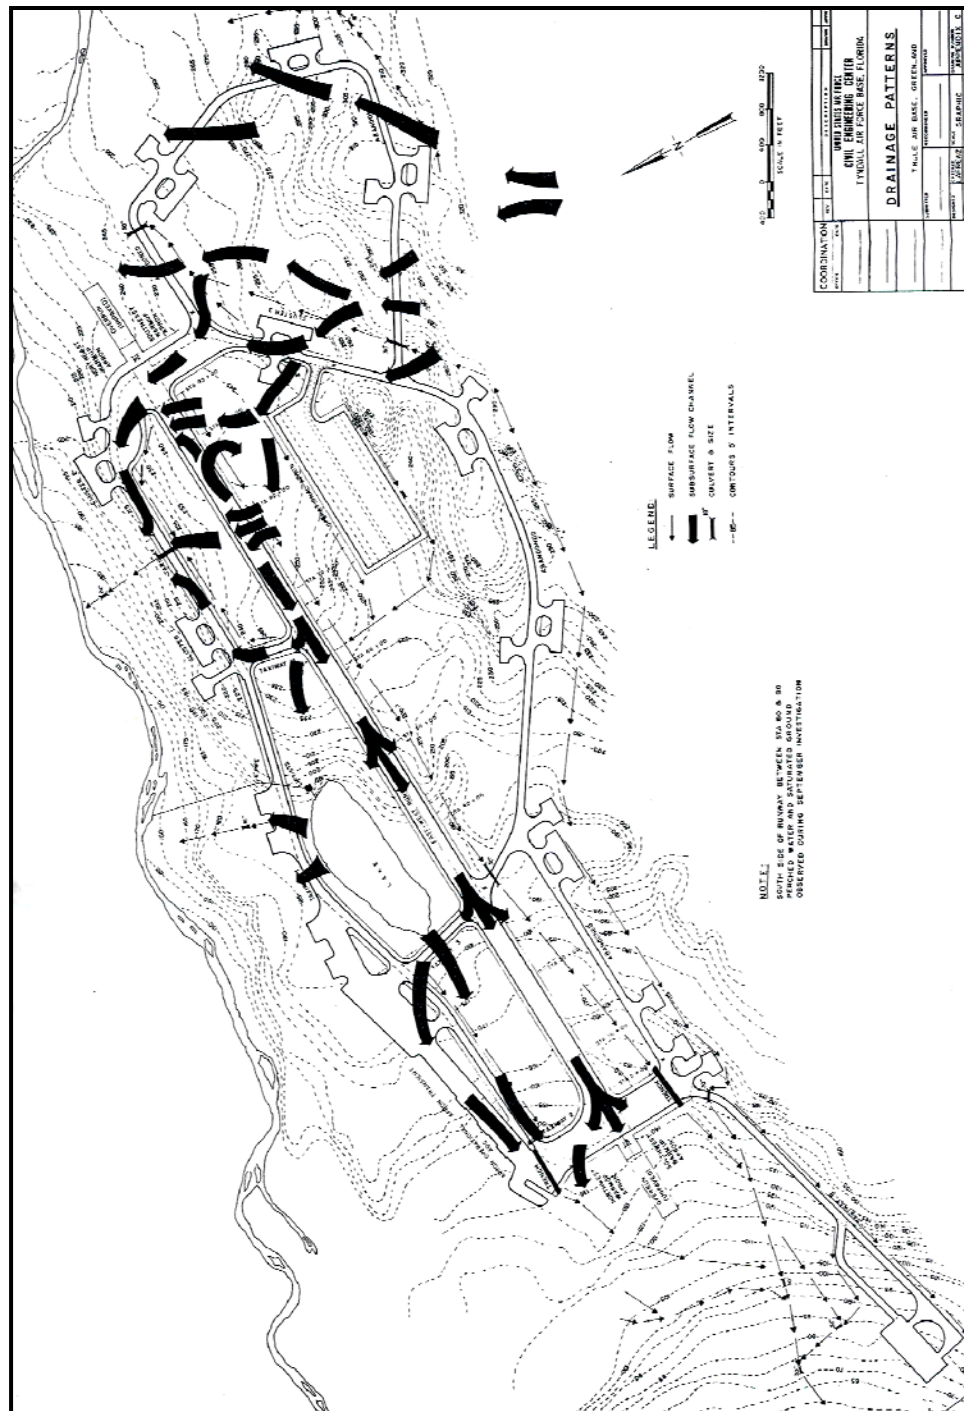
Previous dedicated drainage studies for the airfield (Metcalf & Eddy 1958; Berg 1976) have been conducted. These studies suggest that flow originates from the slopes of South Mountain, with contributions from the area in the direction of DET-1, and then enters the southeast area of the airfield, flowing across the South Loop Taxiway into the runway area. Both studies suggest that the runway and taxiway embankments act as preferential flow paths, and when flow encounters an embankment it migrates longitudinally under its centerline. The studies suggest that a majority of the flow eventually discharges out of the north side of the runway embankment at approximately 80+00 to flow through the culvert under Taxiway Alpha east of Taxiway Charlie (Fig. 39).

Figure 39. Surface water drainage paths and inferred subsurface drainage paths (AFCEC 1974).

Some flow continues to the west into Lake Eddy, under Taxiway Bravo and out under culverts to the west. In 1975, “bird baths” that had developed from 80+00 to 100+00 were suspected to be from groundwater weakened soils. Berg (1976) suggested white painting of this section of the runway; it

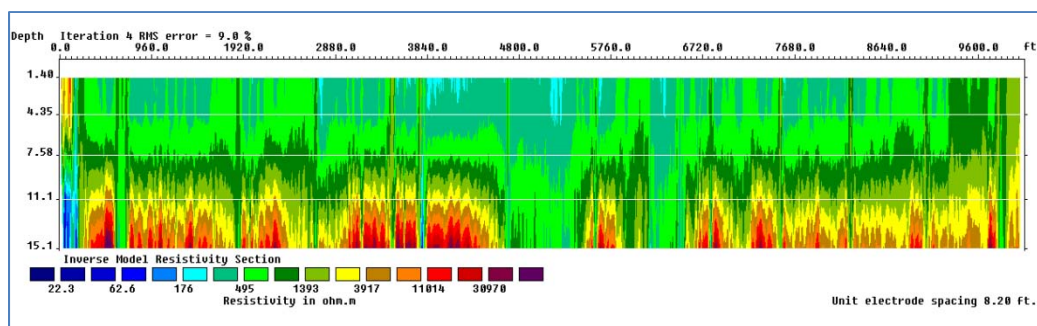
When the validated topographic information for the terrain model was compared to the electrical earth resistivity surveys (CCER), it can be seen that two highly conductive regions exist approximately in the middle of the runway embankment (Fig. 42) at approximately 52+00 and 62+00. These locations correspond to the topographic lows at 52+00 and 62+00. The location at 52+00 is a drainage course that existed prior to construction and would have originated on the south side of the runway at approximately the south shoulder area, extending to the northwest becoming the primary, and possibly only, surface water tributary into Lake Eddy. Sub-

Figure 42. Runway resistivity cross-section from 00+00 to 100+00. The locations of the pre-construction surface drainage feature at ~52+00, and the location of the existing depressions at 62+00 are visible in blue with the lower resistivity (high conductivity). The undulating frozen ground boundary is also clearly defined by the yellow and red shading. (Depth scale is exaggerated in this figure.)
